Manhole Inspection Summary

Manhole # S45CC_037MH

Insp Date: 7/1/08 9:47 AM

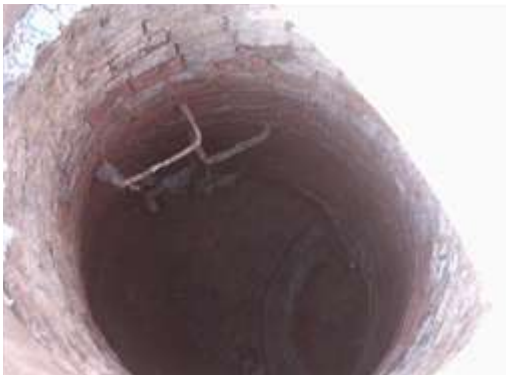
Defect 1

Frame Offset: **1** (in.) Condition: ☐ Sound ☐ Cracked ☒ **Leaks**

Frame Leaks

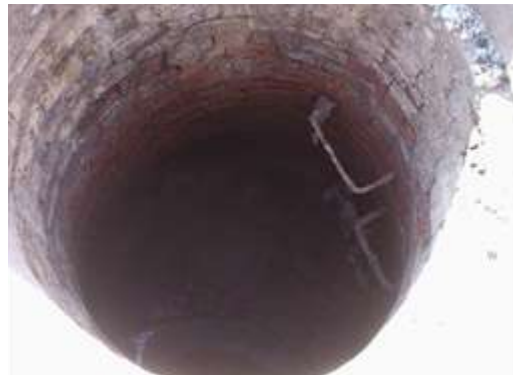
Defect 2

Infiltration: ☐ None ☒ **Joint** ☐ Cracks ☐ Mortar ☐ Roots ☐ Wall

Infiltration: ☐ None ☐ Joint ☐ Cracks ☐ Mortar ☐ Roots ☒ **Wall**

Infiltration

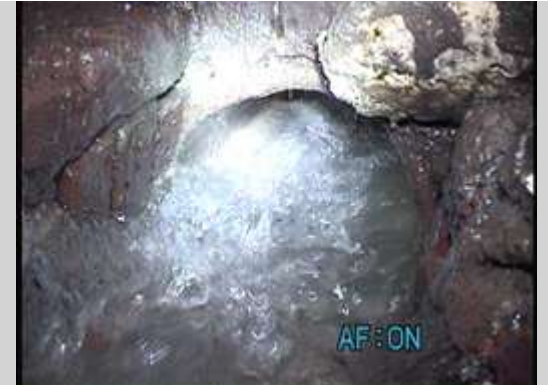
12 O'Clock Outflow

10 in. Circular Gravity Sewer
Pipe Out @ 12 O'Clock

Pipe Height: **10.8** (in.) Rod and Bar (Angled)
Pipe Material: **Clay** ☐ Pipe Lined
Invert Depth: **9.74** (ft.) Flow Characteristics: **Fast**
Deposits: ☒ None ☐ Mud ☐ Sludge ☐ Debris ☐ Grease
Silt Depth: (in.) Deposits Extent:
Infiltration: **None** Pipe Seal Cond: **Sound**

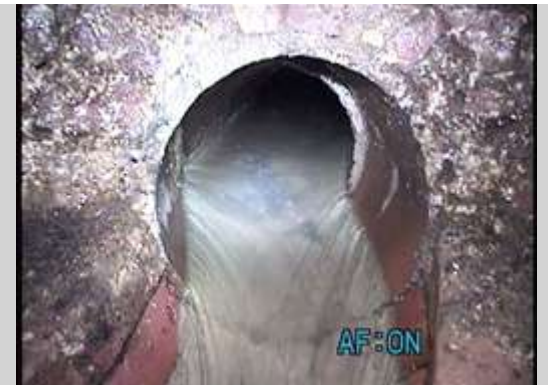
3 O'Clock Inflow

10 in. Circular Gravity Sewer
Pipe In @ 3 O'Clock

Pipe Height: **10.8** (in.) Rod and Bar (Angled)
Pipe Material: **Clay** ☐ Pipe Lined
Invert Depth: **8.60** (ft.) Flow Characteristics: **Fast**
Deposits: ☒ None ☐ Mud ☐ Sludge ☐ Debris ☐ Grease
Silt Depth: (in.) Deposits Extent:
Infiltration: **None** Pipe Seal Cond: **Sound**
